# ELISSA: A WROUGHT IRON

## Part II: Restoration Begins

# ON BARQUE

by: Joe Pehoski  
Doug McLean  
George Holliday

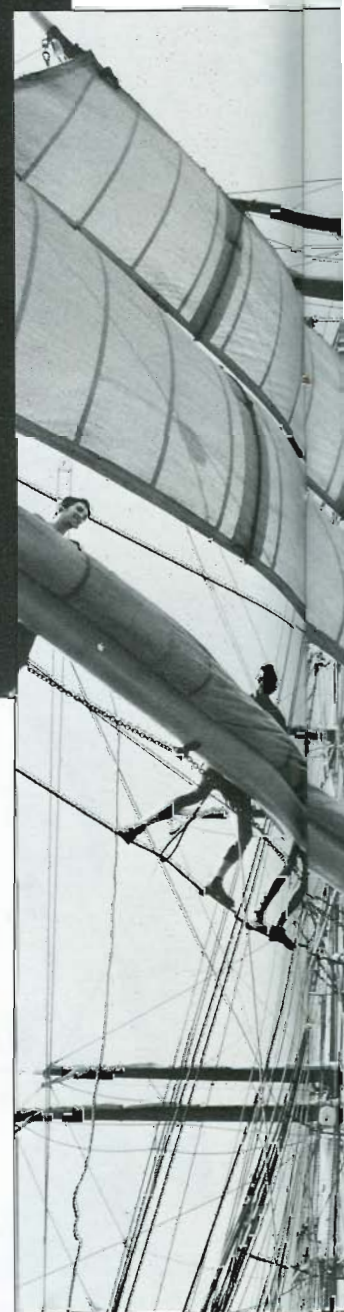
Lower topsail yard crane; 24" H × 18" W × 14" dia.
